**2011 Operations, Maintenance,
and Monitoring Report**

**Cote Blanche Hydrologic
Restoration**

State Project Number TV-04
Priority Project List 3

July 2011
St. Mary Parish

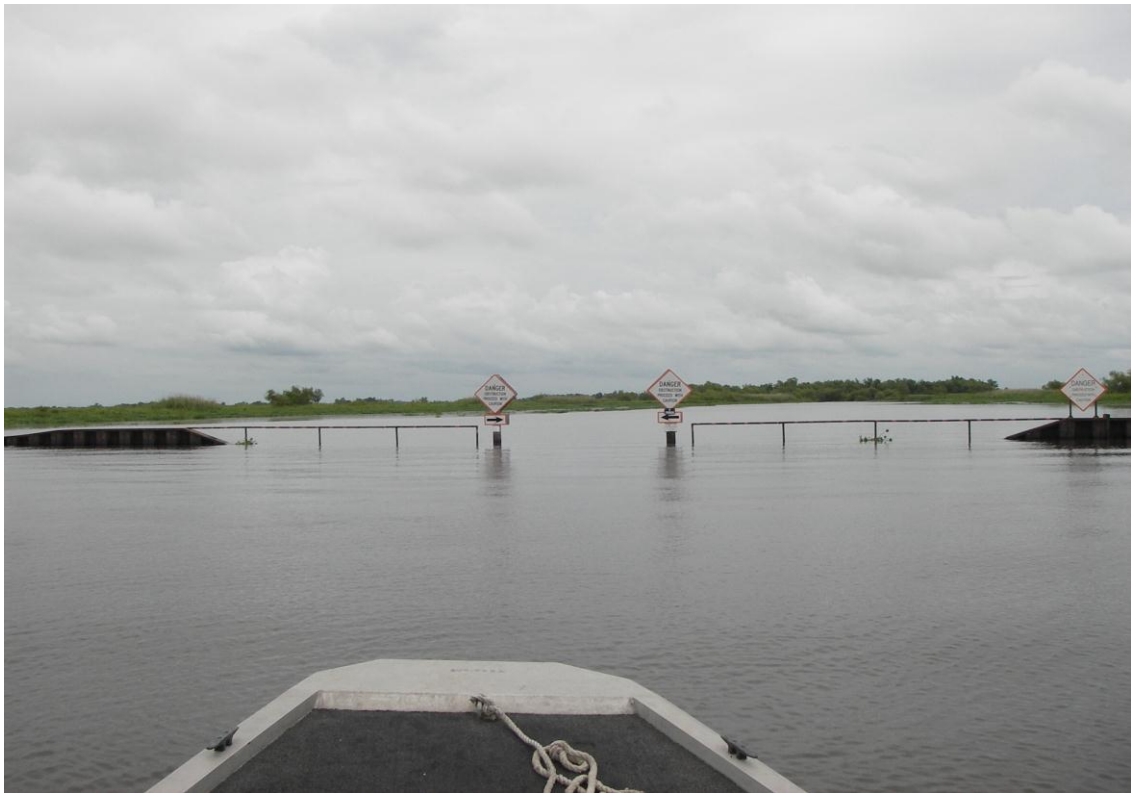
The Mud Bayou structure appears to be holding up fairly well. The coating on the sheet piles is peeling. The steel is beginning to show signs of rust and will need to be monitored. Signage is ok. Staff gauges no longer functional. (Photos: Appendix A, Photo 1).

Photo 1—signage at Mud Bayou

Item	Condition	Physical Damage	Corrosion	Photo #	Observations and Remarks
Steel Bulkhead / Caps	good			1	Structure in good condition and functioning as intended. Rust continues to be monitored. Staff gauges need to be replaced.
Steel Grating	N/A				
Stop Logs	N/A				
Hardware	good				
Timber Piles	good				
Timber Wales	N/A				
Galv. Pile Caps	N/A				
Cables	N/A				
Signage / Supports	good				
Rip Rap (fill)	good				
Earthen Embankment	N/A

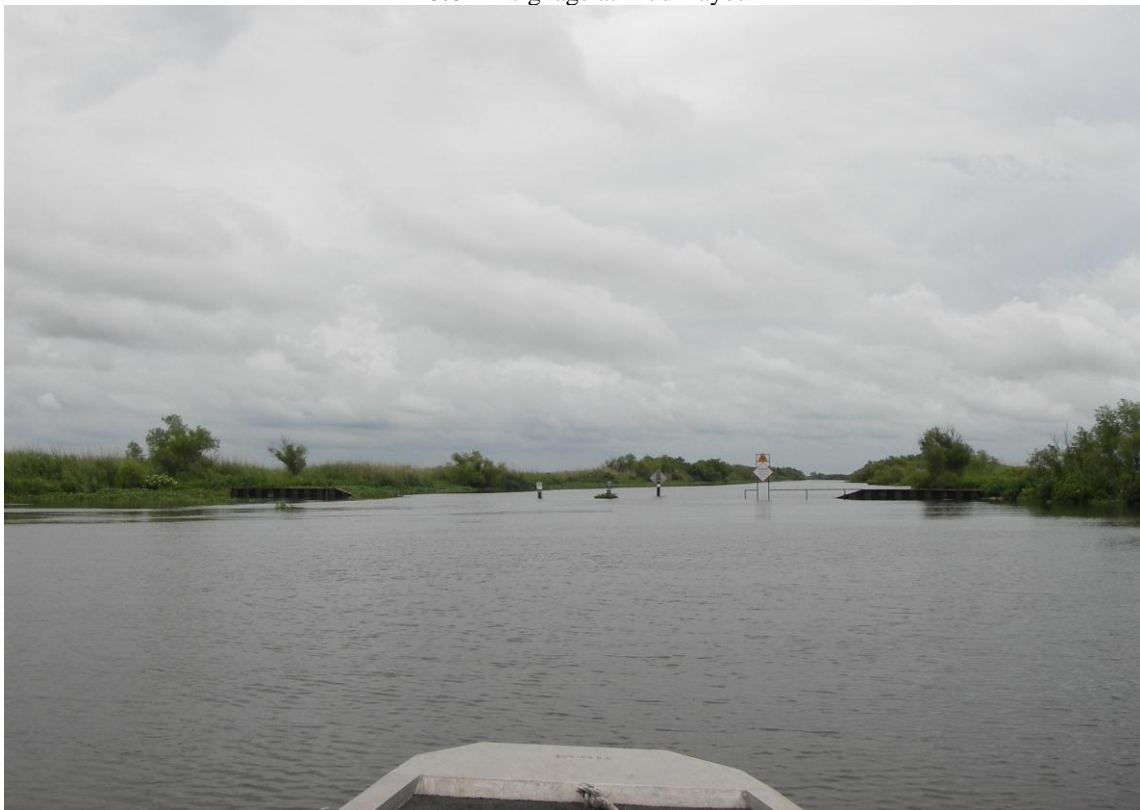
The warning sign, day-marker, and railing on the north side of the structure are gone and will need to be replaced. Sheet piles and rocks on the end of the structure are stable and functioning as intended. The coating on the sheet piles is rusting on this structure and will be monitored as well. The south arrow sign is missing. All signs need to be re-taped. Staff gauge reading was 1.8', but gauges are not stable and will need to be re-set. (Photos: Appendix A, Photo 2).

Photo 2— Missing sign, nav-aid marker, and railing @ Humble F Canal (on left)

Item	Condition	Physical Damage	Corrosion	Photo #	Observations and Remarks
Steel Bulkhead / Caps	good			2	Structure in good condition. Some slight rusting of pile caps.
Steel Grating	N/A				
Stop Logs	N/A				
Hardware	good				
Timber Piles	good				
Timber Wales	N/A				
Galv. Pile Caps	N/A				
Cables	N/A				
Signage / Supports	fair				Warning sign, day marker, arrow sign, and railing on north side are missing.
Rip Rap (fill)	good				
Earthen Embankment	N/A

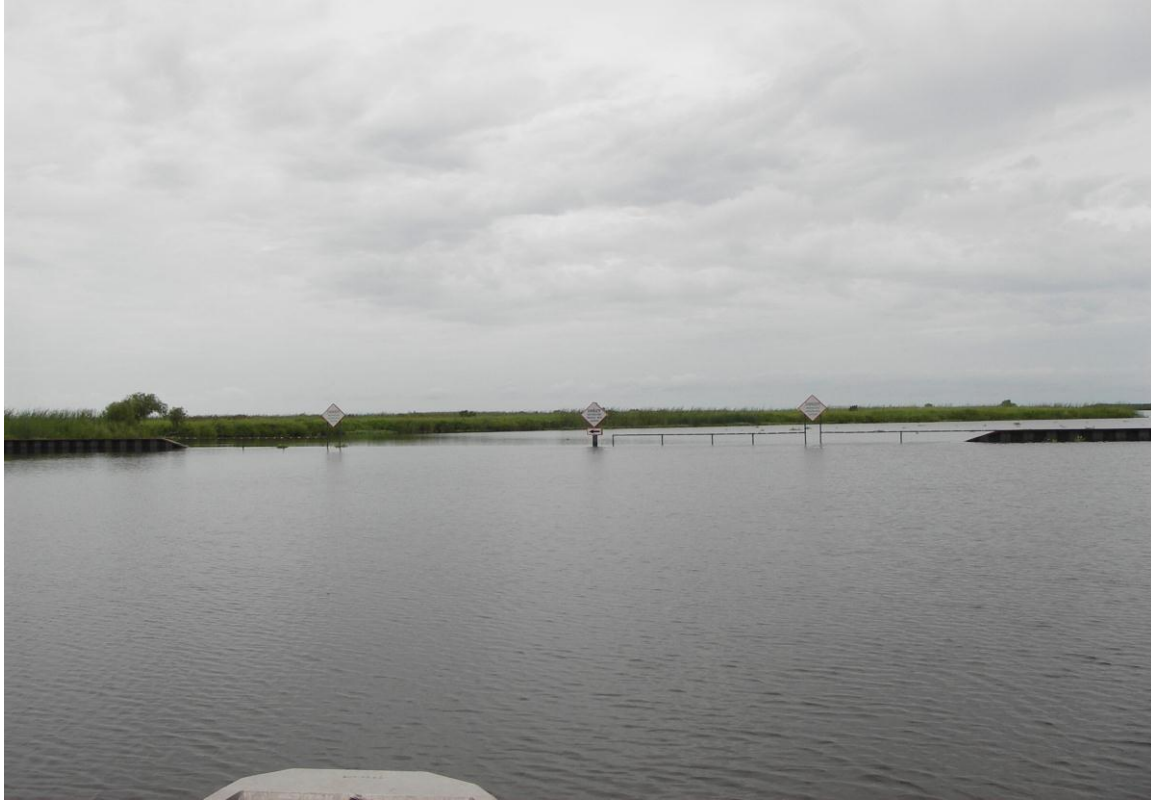
The warning sign/arrow signs and railing on the south end of the structure are missing and will need to be replaced. The coating on the sheet piles is rusting on this structure and will be monitored as well. Staff gauges are no longer functional. (Photos: Appendix A, Photo 3)

Photo 3 – Bayou Long, missing railing and sign (right side)

Item	Condition	Physical Damage	Corrosion	Photo #	Observations and Remarks
Steel Bulkhead / Caps	good				
Steel Grating	N/A				
Stop Logs	N/A				
Hardware	good				
Timber Piles	good				
Timber Wales	N/A				
Galv. Pile Caps	N/A				
Cables	N/A				
Signage / Supports	good			3	Warning sign, arrow sign and railing are missing on the south end of the structure and needs to be replaced.
Rip Rap (fill)	good				
Earthen Embankment	N/A

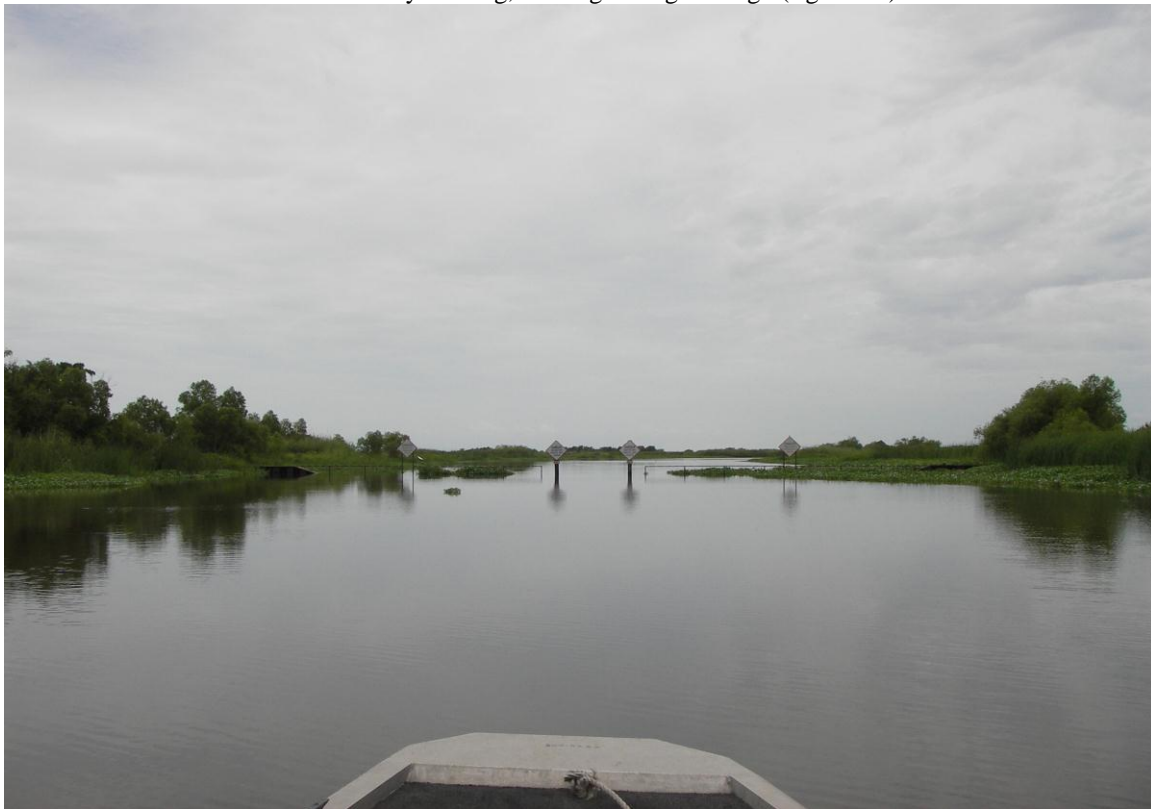
The structure is in excellent post-construction condition. The siltation on the canal between Humble Canal and the structure is no longer as evident as earlier. The Bayou Carlin structure and signage are stable. The coating on the sheet piles is rusting and will be monitored as the others. (Photos: Appendix A, Photo 4)

Photo 4—Bayou Carlin Structure and signage

Item	Condition	Physical Damage	Corrosion	Photo #	Observations and Remarks
Steel Bulkhead / Caps	good			4	Structure in pristine post-construction condition. Some slight rusting of pile caps. No immediate action necessary.
Steel Grating	N/A				
Stop Logs	N/A				
Hardware	good				
Timber Piles	good				
Timber Wales	N/A				
Galv. Pile Caps	N/A				
Cables	N/A				
Signage / Supports	good				
Rip Rap (fill)	N/A				
Earthen Embankment	N/A

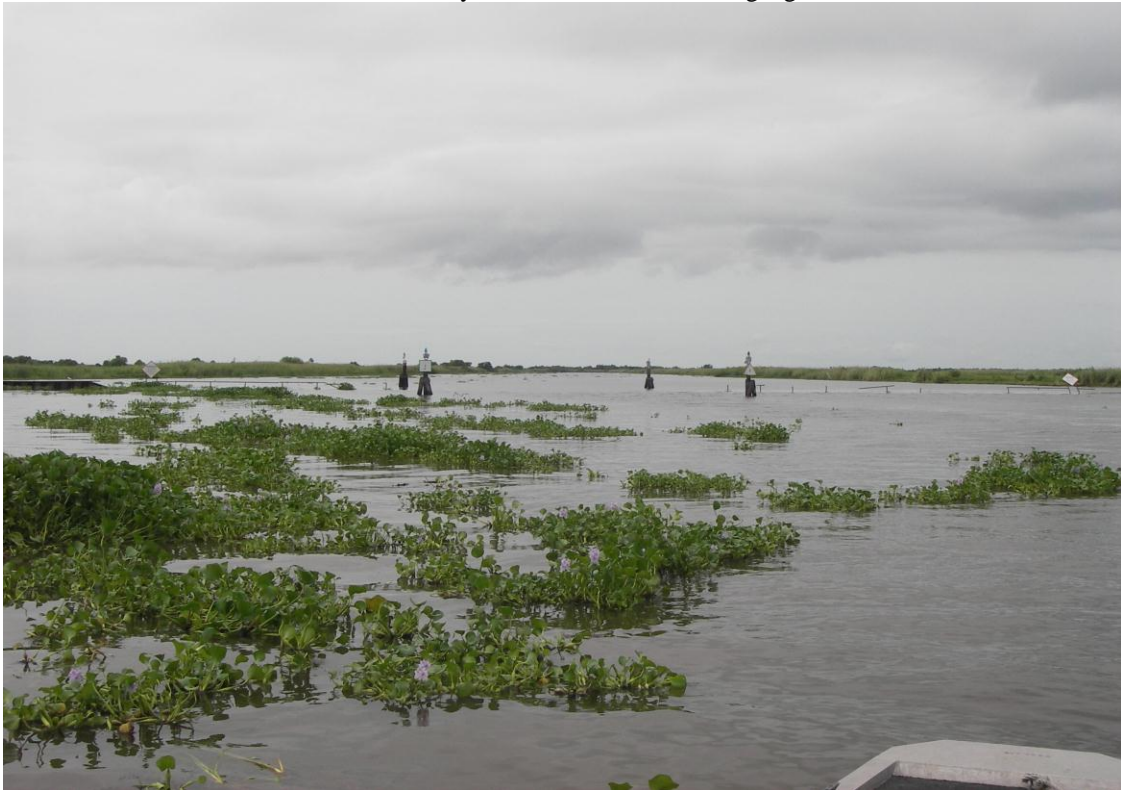
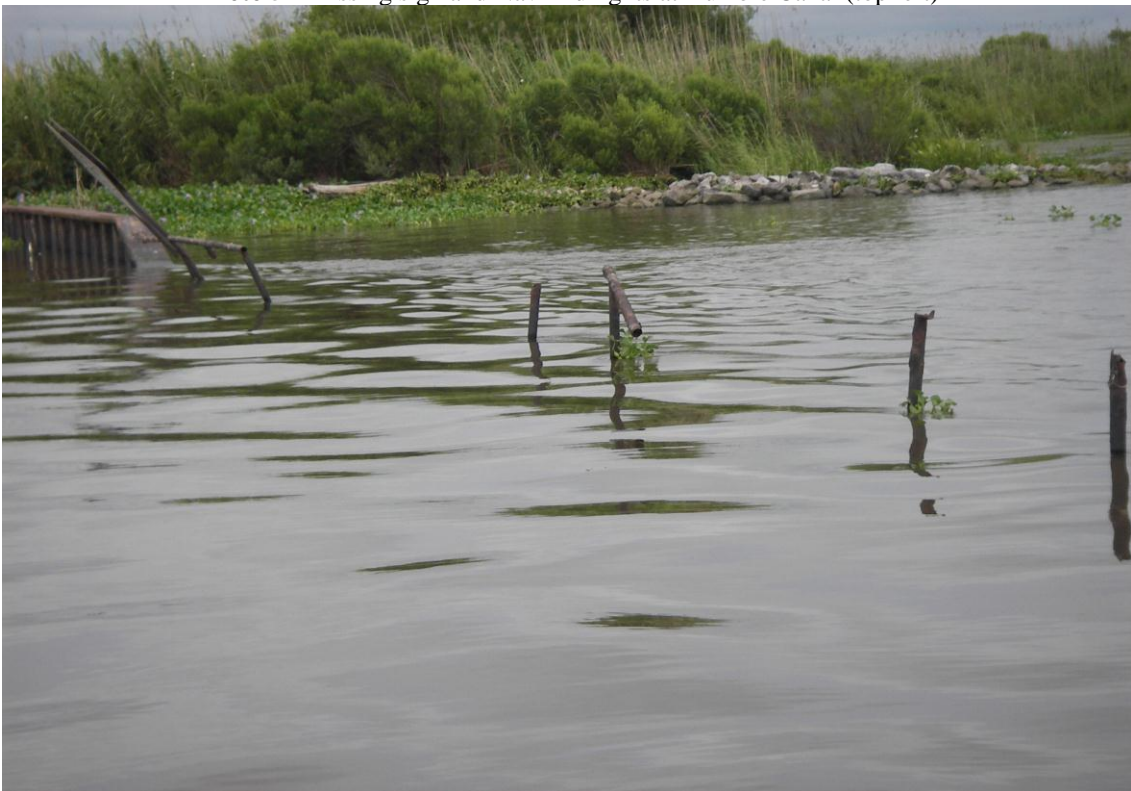
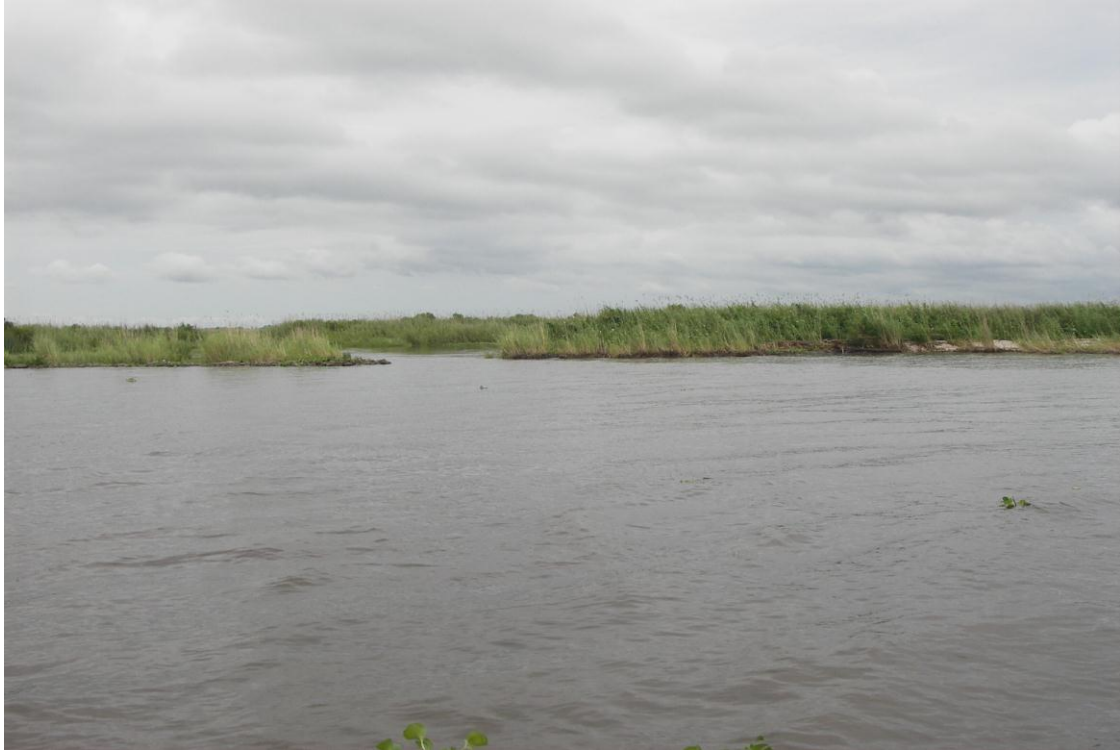
Rail damage on the west end of the structure will be replaced. The danger signs on both ends of the structure are still in place and reusable. The gap on the southern end of the rock dike on the eastern end of Humble Canal has worsened and will be repaired. The rest of the rock around the structure is stable and functioning. The NW coast guard sign is missing and will be replaced. Staff gauges need to be replaced. (Photos: Appendix A, Photos 5-7).

Photo 5—missing sign and Nav-Aid lights at Humble Canal (top left)

Photo 6—damaged rail/sign on Humble Canal

Photo 7—breach in rock on east side of Humble Canal

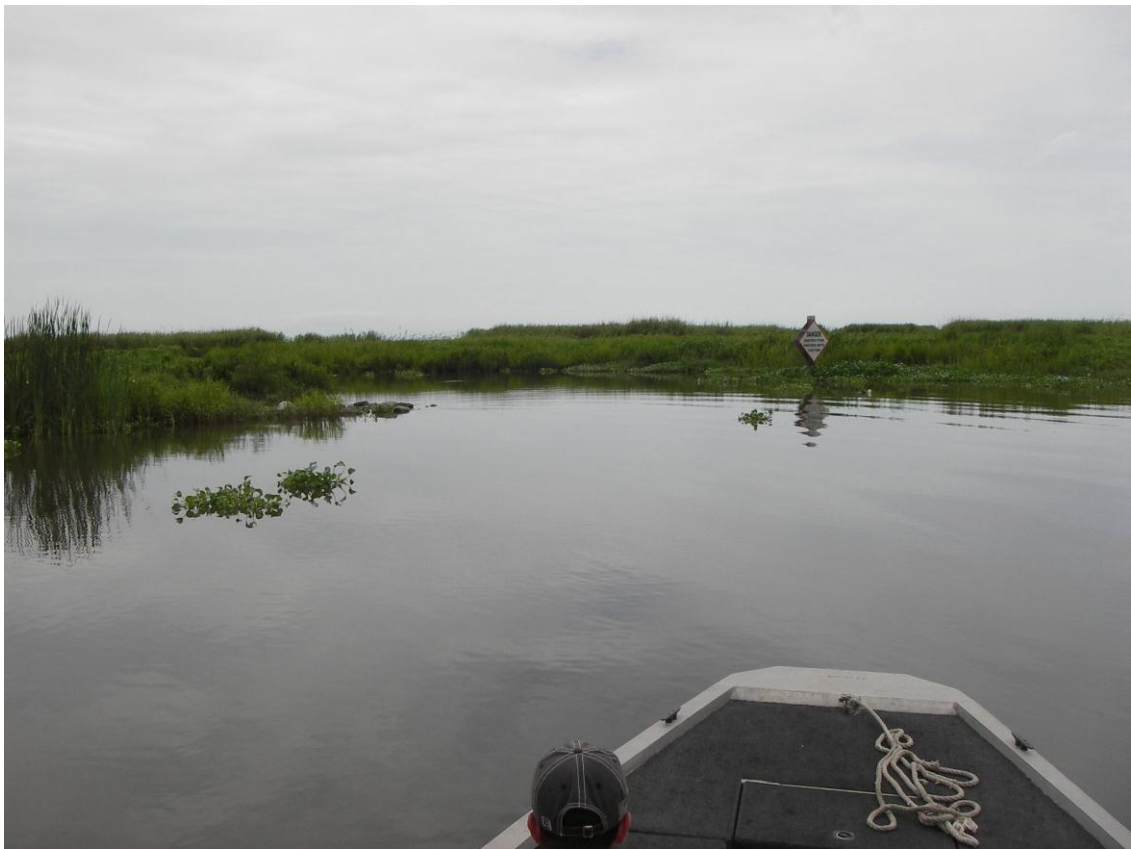
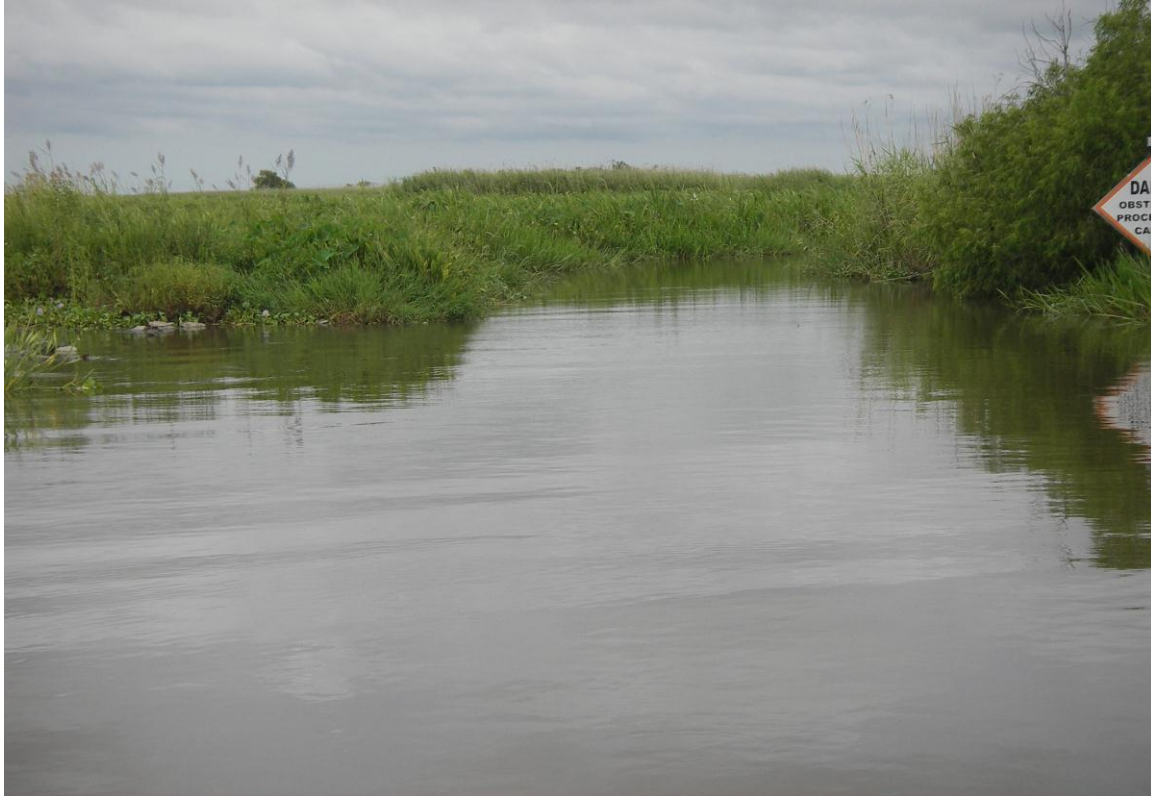
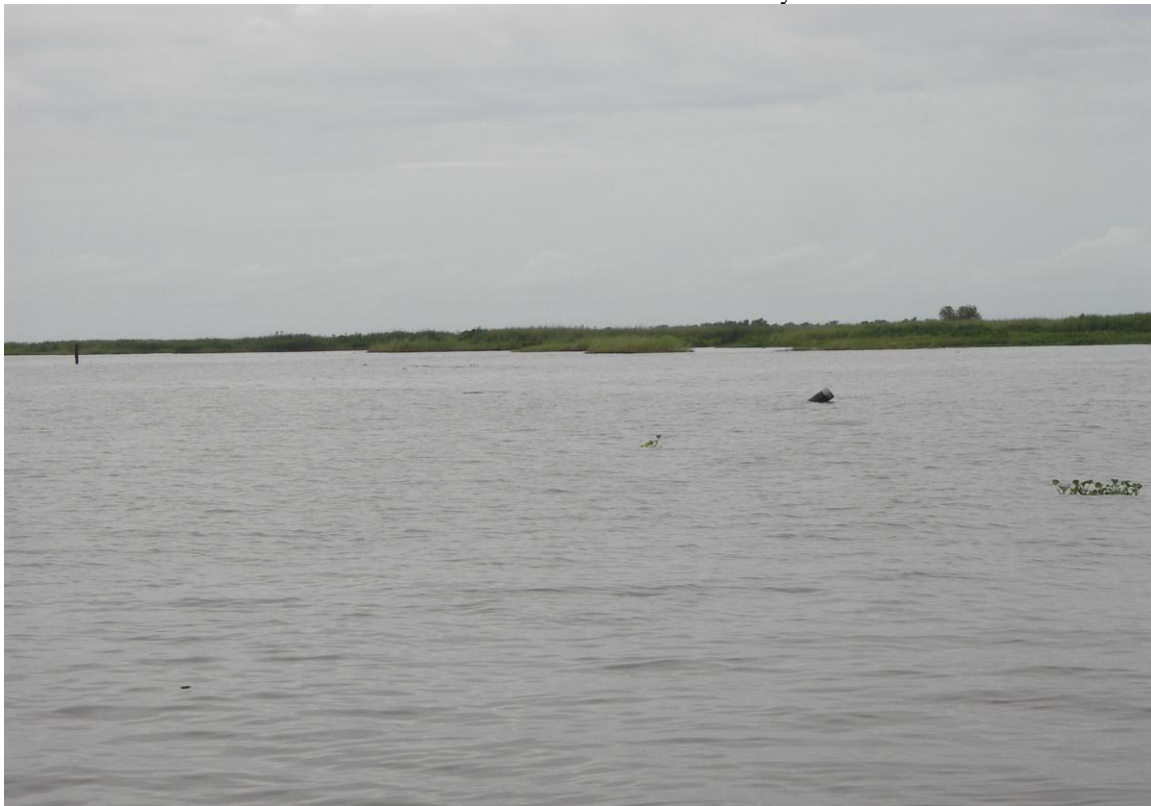
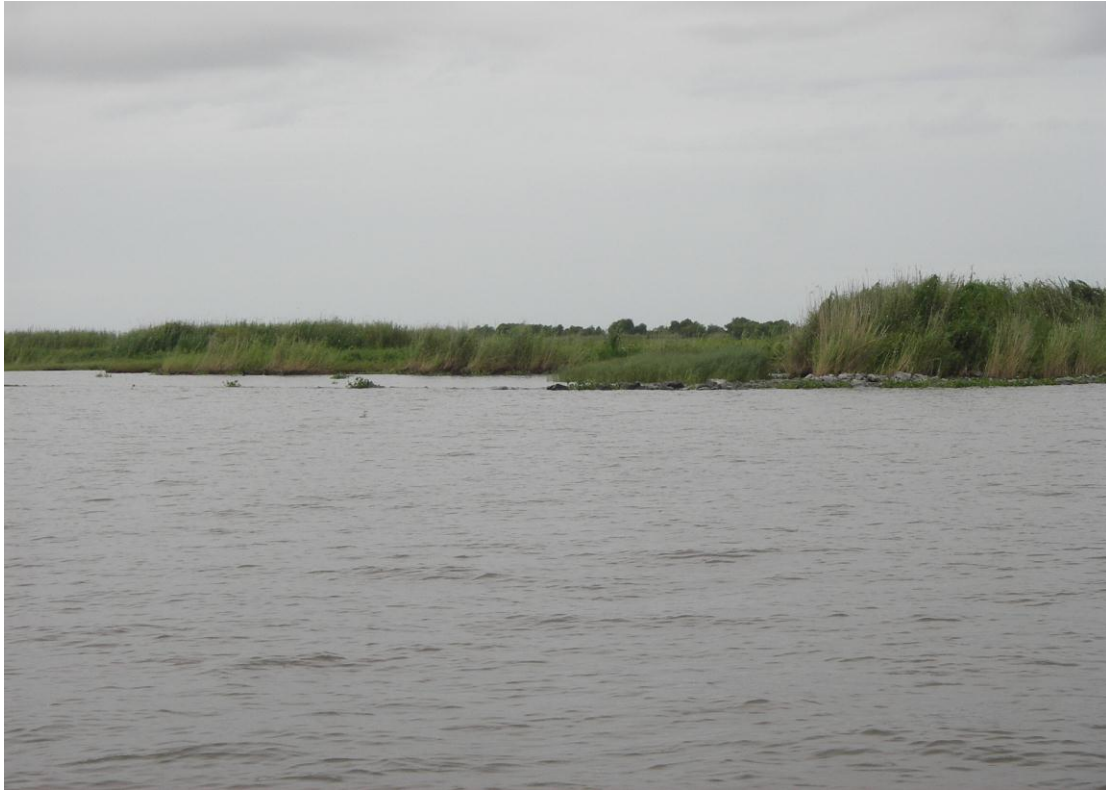
The dike has settled to an approximate average elevation of +2.0 ft NAVD88 and will be recapped. Spoil placed behind the dike is all gone. One warning sign on the foreshore dike was leaning and will be straightened. The rock and the sign on the east end School Bus crossing is in better shape but will be addressed as well. The rock on the west end is gone from the bottom of the channel and will be replaced. The sign is ok. (Photos: Appendix A, Photos 8-11).

Photo 8—western weir at School Bus Bayou

Photo 9— eastern weir at School Bus Bayou

Photo 10—leaning sign and typical section of School Bus dike rock

Photo 11—typical section of School Bus dike

Item	Condition	Physical Damage	Corrosion	Photo #	Observations and Remarks
Steel Bulkhead / Caps	N/A				
Steel Grating	N/A				
Stop Logs	N/A				
Hardware	N/A				
Timber Piles	N/A				
Timber Wales	N/A				
Galv. Pile Caps	N/A				
Cables	N/A				
Signage / Supports	Good			10	One sign is down and needs to be replaced. Others need reflective tape.
Rip Rap (fill)	Good			11	Settlement of rock dike has become significant and will need to be raised. Tie-ins stable.
School Bus Bayou	Good			8, 9	Rock at bottom of each wier will be addressed.
Low Level Weirs					
Earthen Embankment	N/A

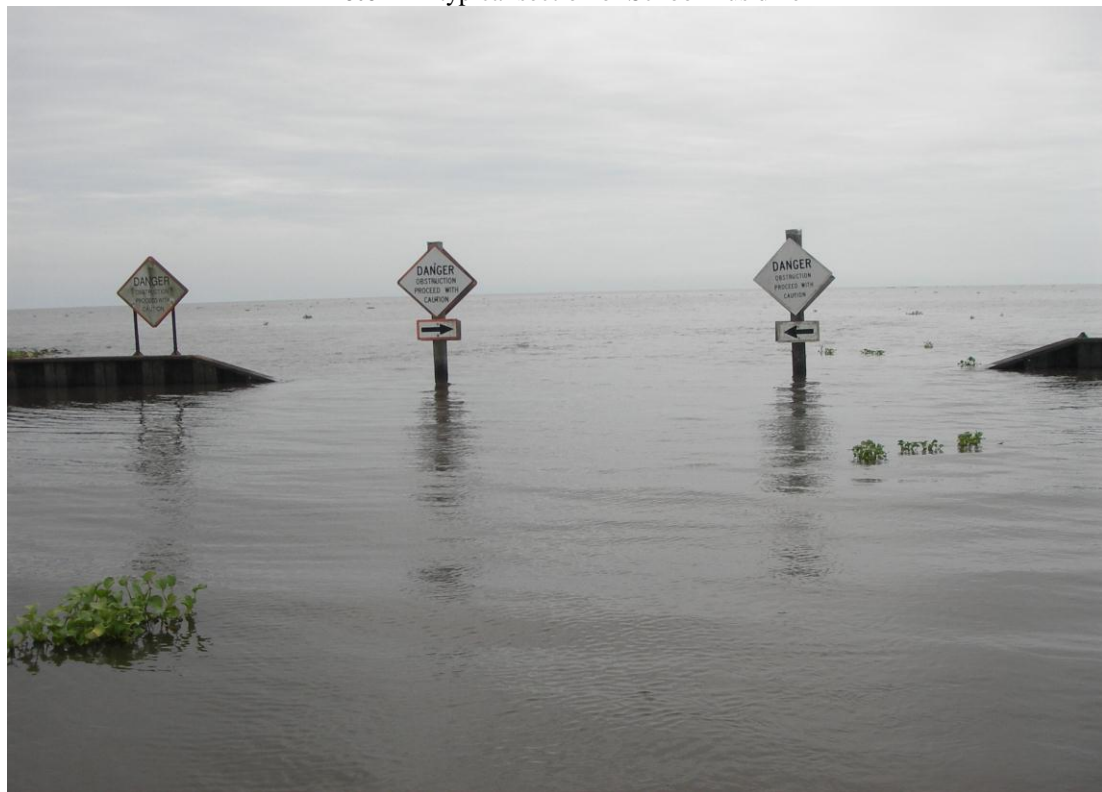
The warning sign mounted on the left side of the structure is gone and will be replaced. Existing signs need to be re-taped. The rock placed on both sides of the structure has stabilized the shoreline. The coating on the sheet piles is rusting on this structure and will be monitored. The west warning sign is gone and will need to be replaced. (Photos: Appendix A, Photo 12).

Photo 12— Jackson Bayou (missing sign on right)

Item	Condition	Physical Damage	Corrosion	Photo #	Observations and Remarks
Steel Bulkhead / Caps	good			12	Some slight rusting of pile caps. No immediate action necessary.
Steel Grating	N/A				
Stop Logs	N/A				
Hardware	good				
Timber Piles	poor				
Timber Wales	N/A				
Galv. Pile Caps	N/A				
Cables	N/A				
Signage / Supports	good				Warning sign on left side of structure is gone and needs to be replaced. Existing signs need to be retaped with reflective tape.
Rip Rap (fill)	good				Shoreline has been stabilized by the placement of rock.
Earthen Embankment	N/A

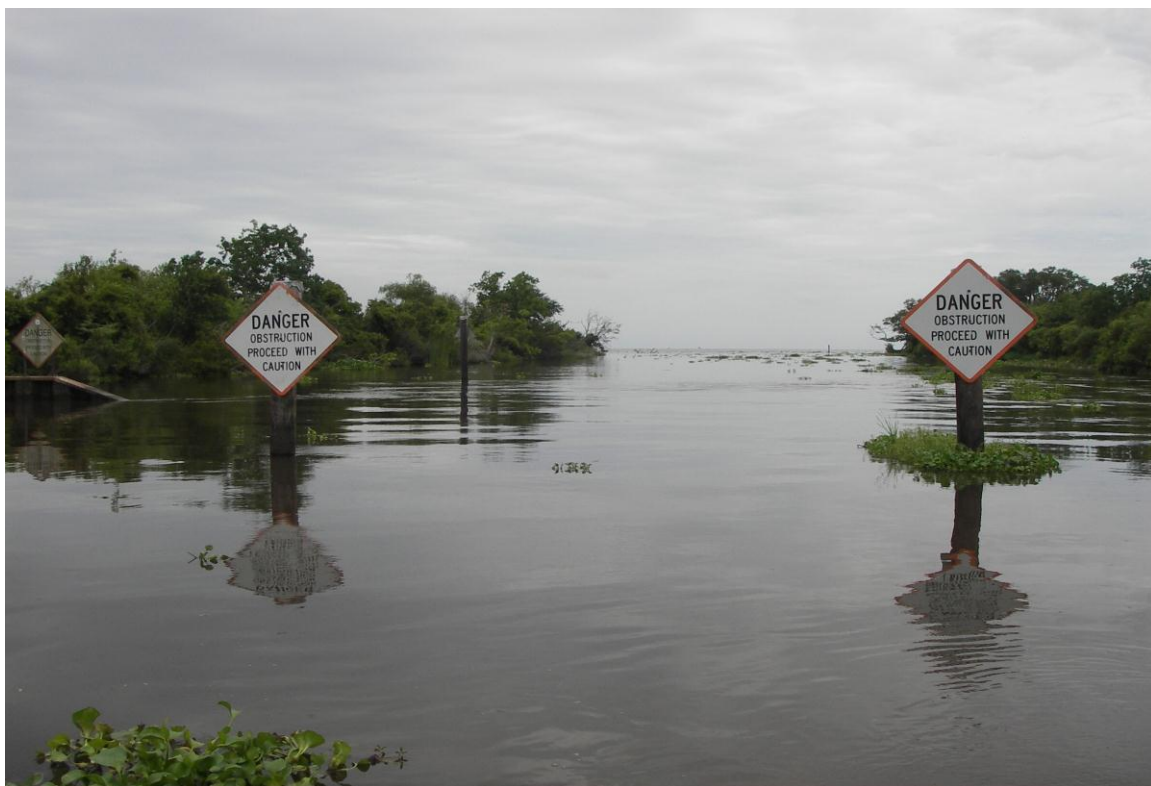
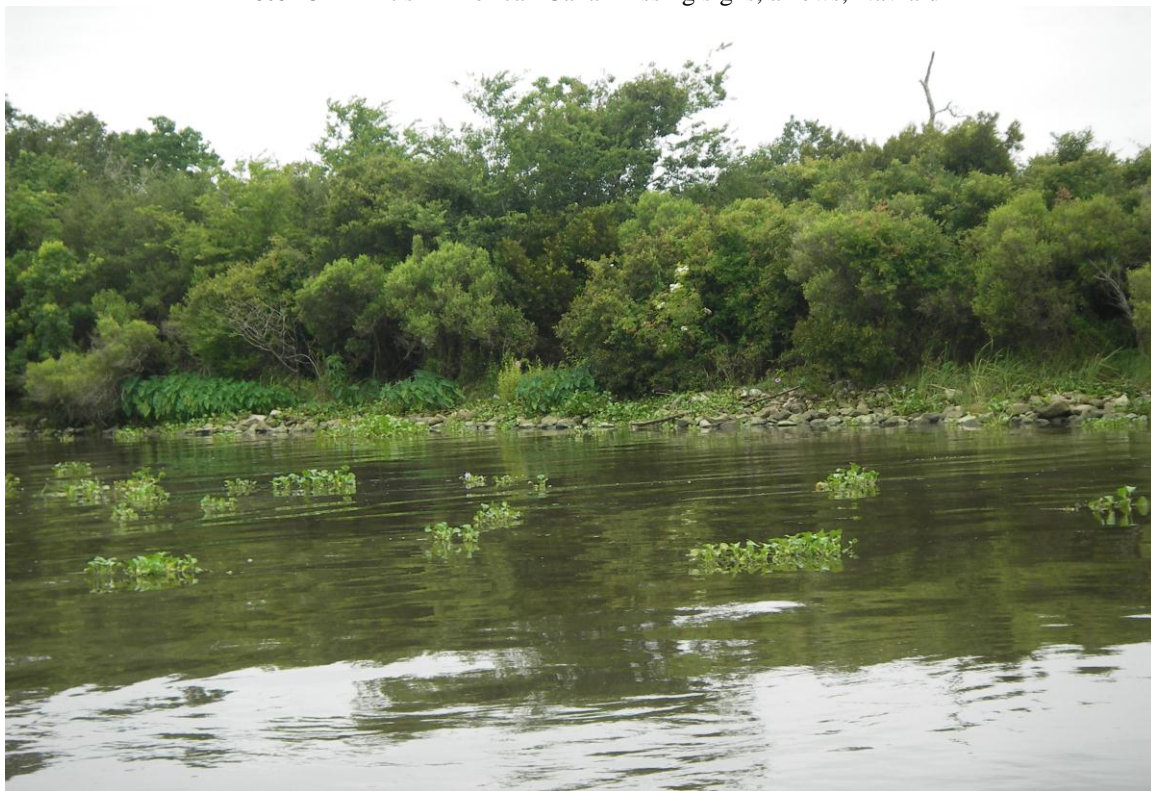
The western (green) navigational aid marker is gone and will be replaced. The coating on the sheet piles is rusting on this structure and will be monitored as well. Warning signs and arrows will be replaced. Other signs will be re-taped. The rock on the wingwalls of the structure as well as the rock along the canal is stable. The rock between the PVC wall and the bank has settled but is still functional. (Photos: Appendix A, Photos 13-14).

Photo 13— British American Canal missing signs, arrows, Nav-aid

Photo 14—rock along British American Canal

Item	Condition	Physical Damage	Corrosion	Photo #	Observations and Remarks
Steel Bulkhead / Caps	good			13, 14	Some initial post construction rusting. No action needed.
Steel Grating	N/A				
Stop Logs	N/A				
Hardware	good				
Timber Piles	N/A				
Timber Wales	N/A				
Galv. Pile Caps	N/A				
Cables	N/A				
Signage / Supports	good				Navigational Aid, Arrows, and Warning Signs missing. Existing Signs need to be re-taped.
Rip Rap (fill)	good				Rock between PVC wall and shoreline has settled but is still functional.
Earthen Embankment	N/A

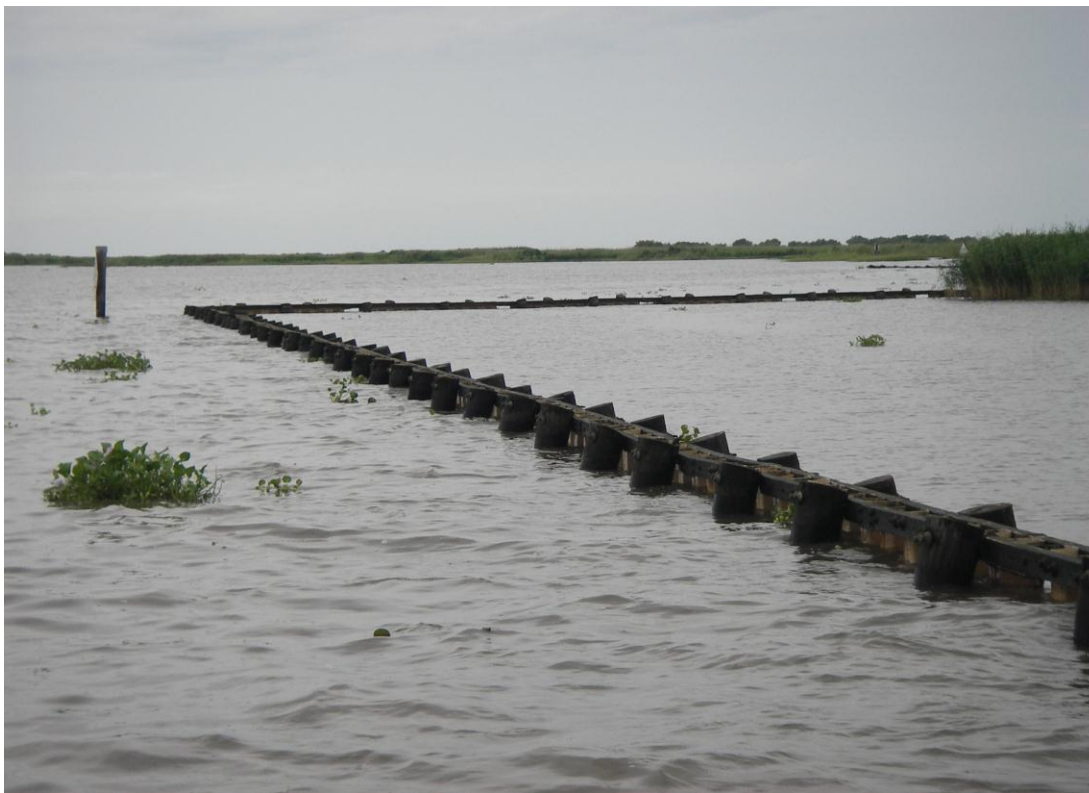
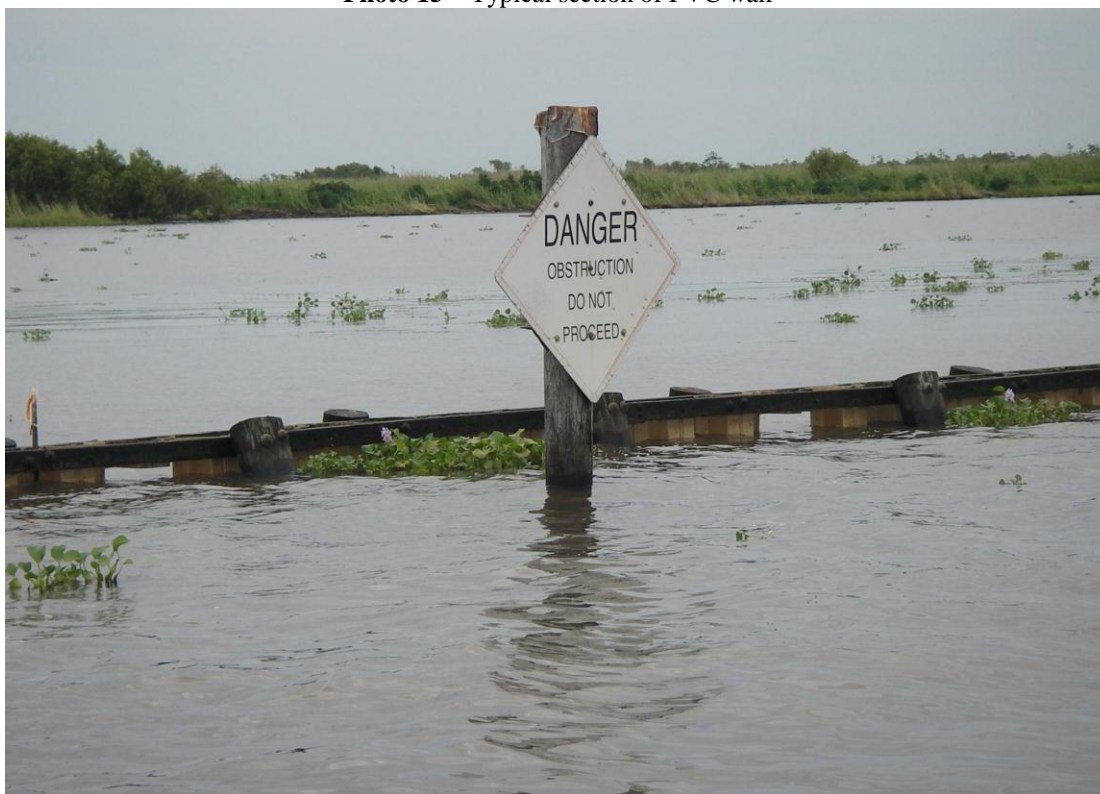
The PVC shoreline protection wall and signage are stable. There are virtually no pile caps remaining, but no damage to the timber piles was noticed. Previous attempts to replace these pile caps have been unsuccessful. The piles will be monitored and should the need arise, will be painted or coated for protection. Sheet piles in several locations are missing; however, no gaps are wider than 3-4 feet. Replacement of these sheet piles may not be possible due to the rock at the base. The wall is still functioning as intended. Signs are all in place however, they will need to be re-taped. (Photos: Appendix A, Photos 15-16).

Photo 15—Typical section of PVC wall

Photo 16—Sign/section of PVC wall

Item	Condition	Physical Damage	Corrosion	Photo #	Observations and Remarks
PVC sheet piling / Caps	fair			15, 16	PVC wall appears to be in post construction condition and holding up well. Some piles have been broken or displaced. No gaps are wider than 3-4 feet however, and the wall is still functioning.
Steel Grating					
Stop Logs					
Hardware	good				
Timber Piles	good				Some pile caps missing again. Attempts to replace them has been unsuccessful. Condition of piles will be monitored.
Timber Wales	good				
Galv. Pile Caps					
Cables					
Signage / Supports	good				All signs in place. Some retaping with reflective tape is required.
Rip Rap (fill)	good				Rock placed along the inside and outside of the PVC wall is still in place and functional. No action necessary.
Earthen Embankment
